**ARCHAEOLOGY AND ARCHITECTURE:
SPANISH-ERA RUINS ALONG BAHÍA SAN LUIS
GONZAGA, BAJA CALIFORNIA**

Eric W. Ritter

University of California

GONZAGA 2 TEST EXCAVATIONS

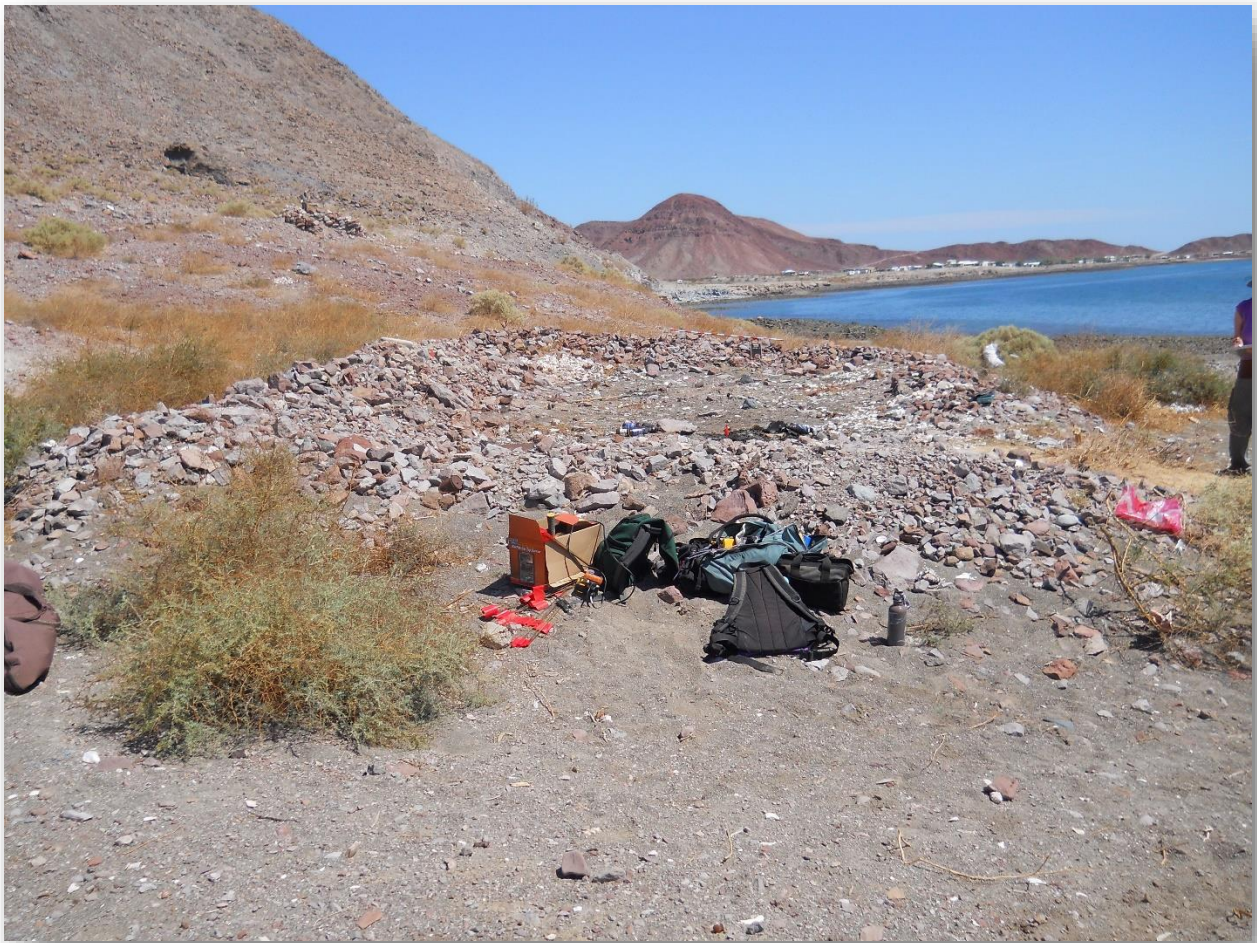
Figure 2. View northerly of foundation

Modern visitors to Bahía San Luis Gonzaga have speculated on the rock foundations along the smaller Ensenada de San Francisquito (Figures 1 and 2). For instance, in Gerhard and Gulick's 1962 *Lower California Guidebook* (first printing in 1956) on page 84 they state "When explored by Jesuit Padre Fernando Consag in 1746, San Luis Gonzaga Bay was found uninhabited for lack of water, though frequently visited by Indians for fishing. In 1767 it became a supply point for the last Jesuit mission, Santa María, about 14 miles to the southwest. Ruins of a stone structure, likely a storehouse, dating from the mission period may still be seen near the shore of the bay." During our expedition to this bay local residents also suggested the ruins, recorded as site Gonzaga 2, were from the Spanish era, a location that had seen considerable relic collection and disturbances over the years.

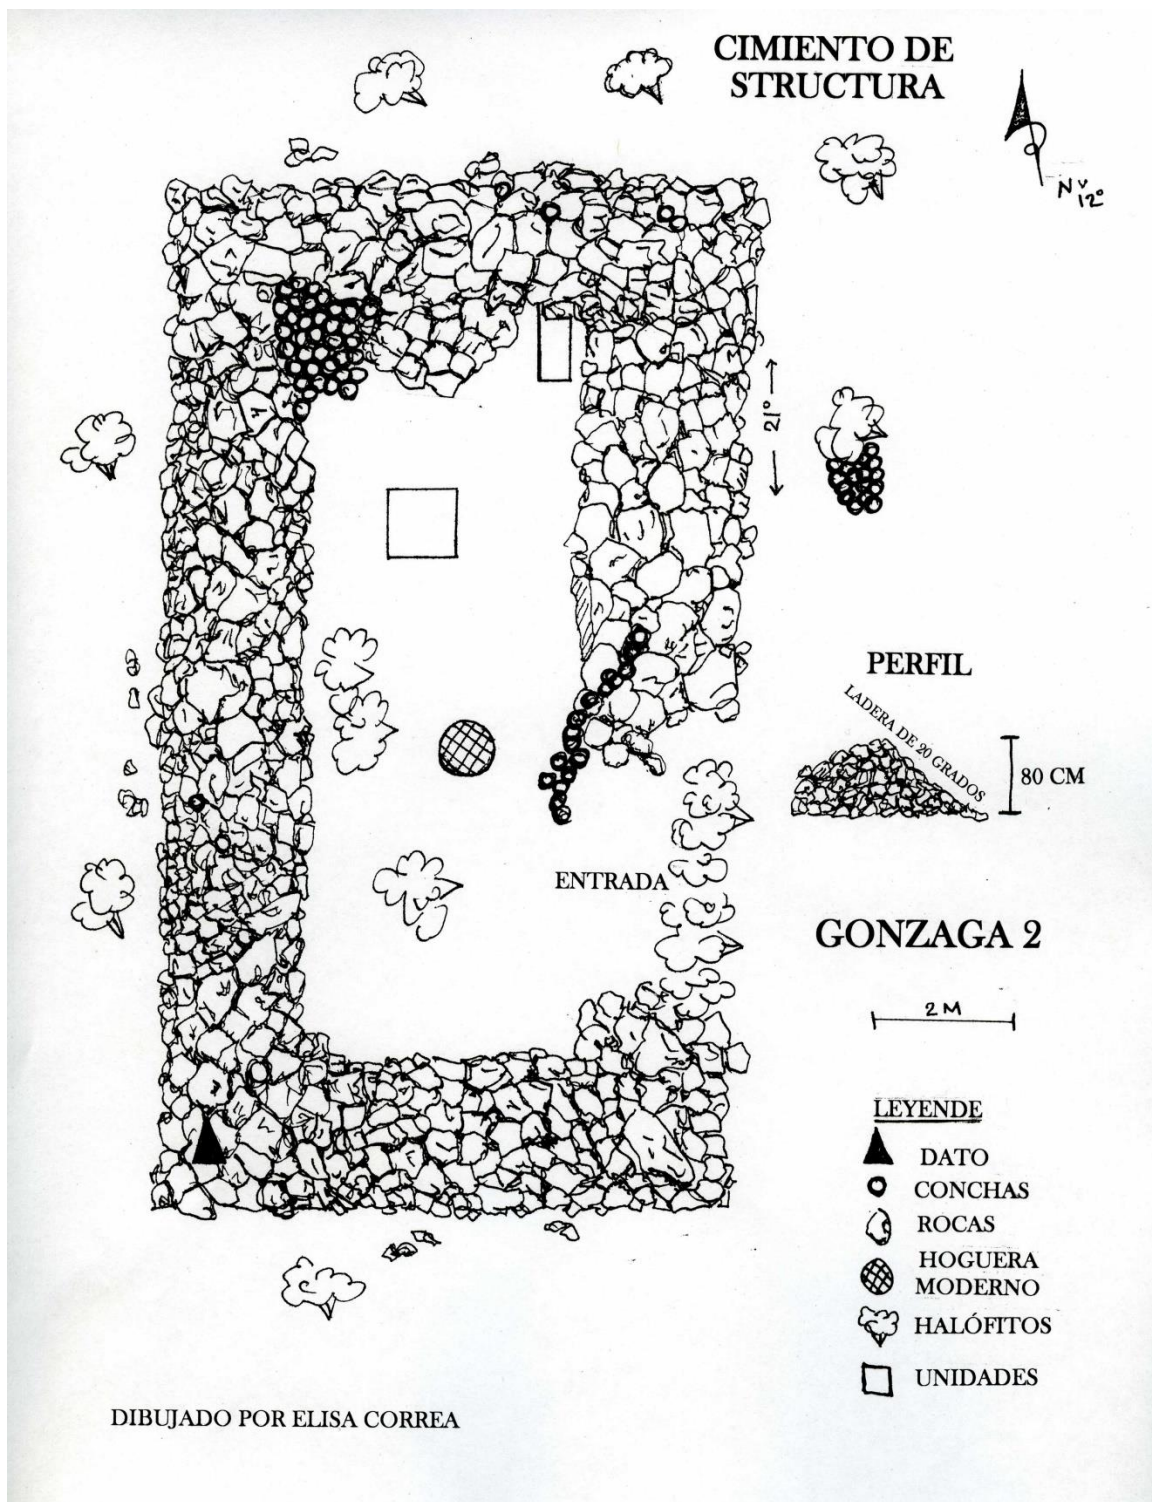
Figure 3. Plan view of foundation and excavation units

interior dimensions, considering some wall collapse, are 10 m by 4 m. The wall height is 80 cm. A doorway lies on the easterly wall toward the southerly end, about 3 m wide as seen in the accompanying figure (Figure 3). A review of a 1958 digital image taken from a slide of Howard E. Gulick (University of California, San Diego, Special Collections MSS 91, Roll 17, Frame 13, Box 1, Folder 14) of the ruins shows more complete stacked rock walls and a monument of rocks (top most are whitewashed) on the center northerly wall (Figure 4). It is likely that some of the rocks from the walls were utilized by the Mexican military who built stone features and alignment nearby in the recent past and that the original foundation was somewhat higher.

The excavation units were oriented according to the alignment of the foundation (21° east of north) with metal pins set for string line corners (Figure 3). Excavation of Unit 1 followed the nearly flat ground contours utilizing arbitrary 10 cm levels. There was a maximum of 4 cm difference in elevation between the highest and lowest corner elevations. The unit was 1 m x 1 m in size. Unit 2 was 1 m x 0.5 m in size with the length aligned similar to that of Unit 1 beginning at the top of the rubble wall and extending southerly onto the interior structure floor (Figure 3). This unit was excavated without arbitrary levels to expose the wall-floor junction and determine foundation construction (Figures 6 and 7).

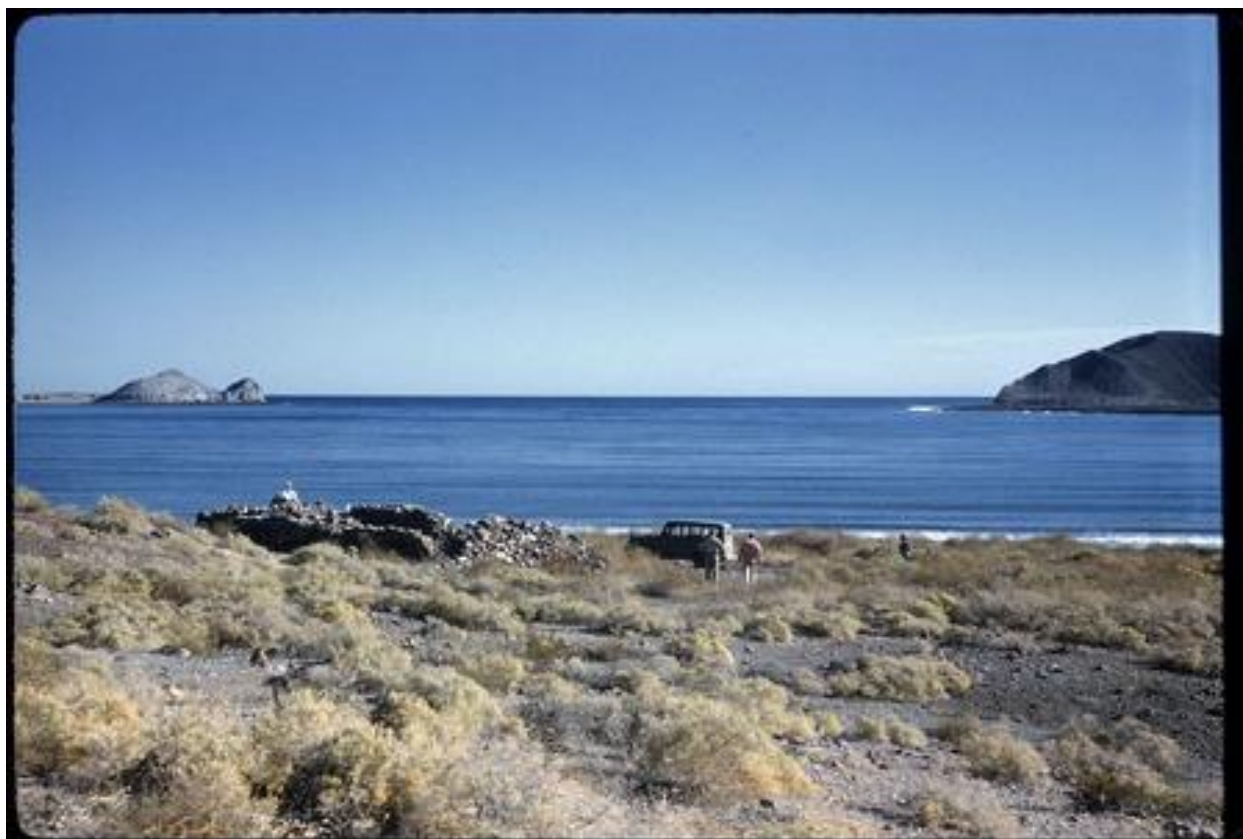
Figure 4. Photo of ruins in 1958 by Howard Gulick

One of the early lime mortar and stone construction techniques employed by the Spanish in their world colonialism is mampostería where masons mortared together stone rubble walls. While there are many examples throughout the world including Mérida, Mexico (J.J. Yucatan 2011), Guam (Cunningham 2011, Jones 1976) and Puerto Rico (Jopling 1992) to list a few, suffice it to say that the Bahía San Luis Gonzaga walls seem similarly constructed. Rock and sand and water were no issue being easily available in the immediate surroundings. But what about the lime for the mortar? There is an easy answer. Just a few hundred meters distant on the adjoining hill there is a sizeable concentration of caliche that has been quarried in modern times and likely earlier, and it is easily accessible, a trail leading from near the ruins up the hill to the quarry a few hundred meters or so (Figure 10). This Calcium Carbonate rich rock would need to be fired at a temperature of 900-1200° C to form the lime for the mortar binder (Walter 2010:72) as was the case at a mission in Texas and evident through the ruins of a caliche-burning kiln seen by this writer at Mission San Borja in the central peninsula. This lime was also used for plaster and whitewashing walls. While no kiln or burning area was noted in an incomplete survey, modern mining could have destroyed such a feature. Mixing the lime with sea water to form the mortar to hold together the sand and rock rubble walls seems highly likely. Eventually the mortar would have been leached out leaving the rubble wall remnants of today and the more complete wall lacking evidence of mortar on the exterior walls in the 1958 Gulick image.

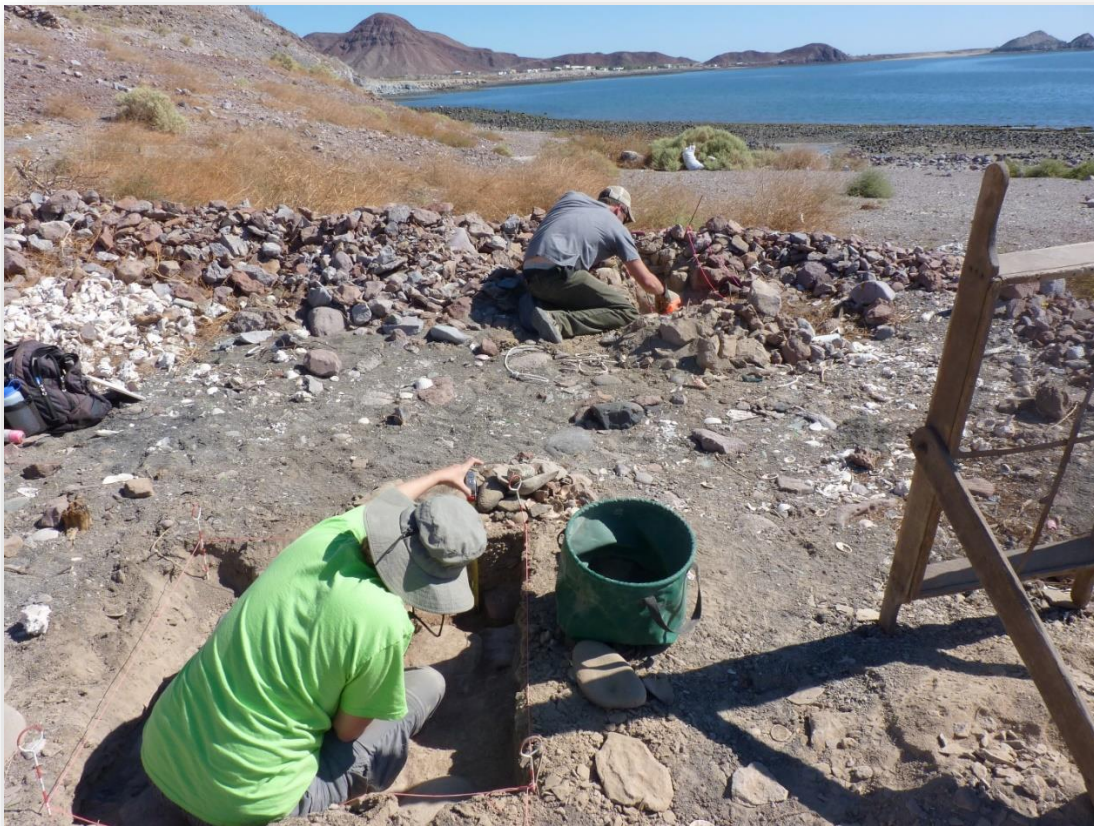
Figure 5. Ruins under excavation

Unit excavation was undertaken with pointing trowels, small archaeology pick, whisk brooms, plastic scoops and buckets, with removed materials taken to a nearby 1/8th inch (3 mm) screen over a plastic tarp for cultural items' recovery (Figure 5). For Unit 1 the 0-10 cm level sediments/soil were a gray (Munsell 10YR 6/1-dry), loose to slightly hard (crusty) gravelly sand. Recent trash, shellfish remains, and charcoal were found with a few older cultural items discussed below.

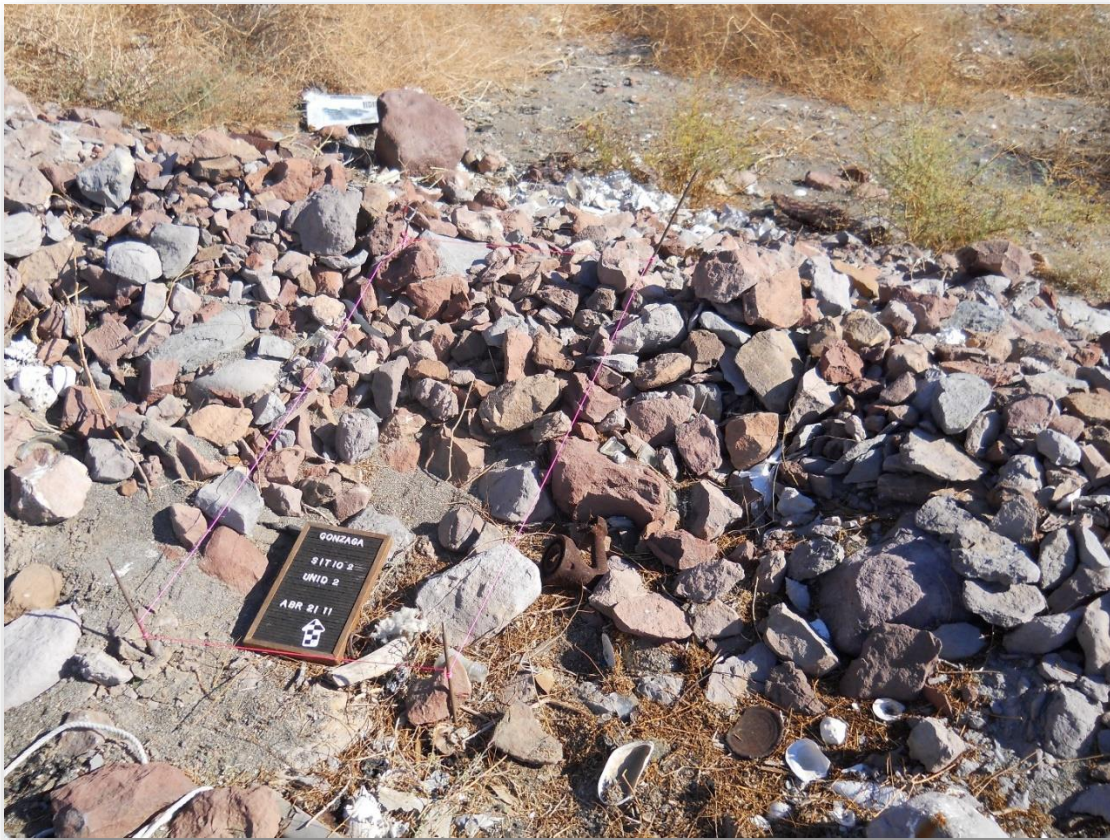
Figure 6. Unit along northerly wall ready for excavation

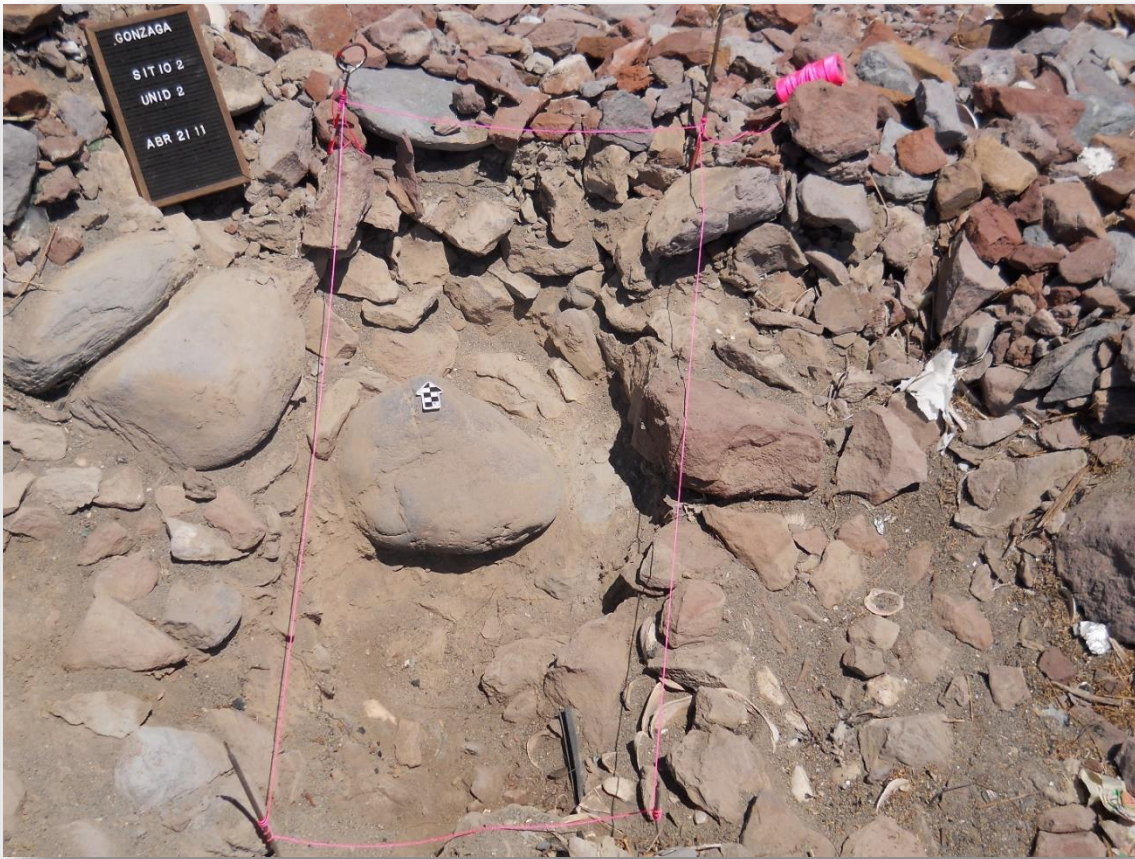
Figure 7. Excavated north or seaward wall foundation

abundant throughout the wall matrix. Shellfish remains and modern trash are also scattered throughout the wall matrix (see Figure 7).

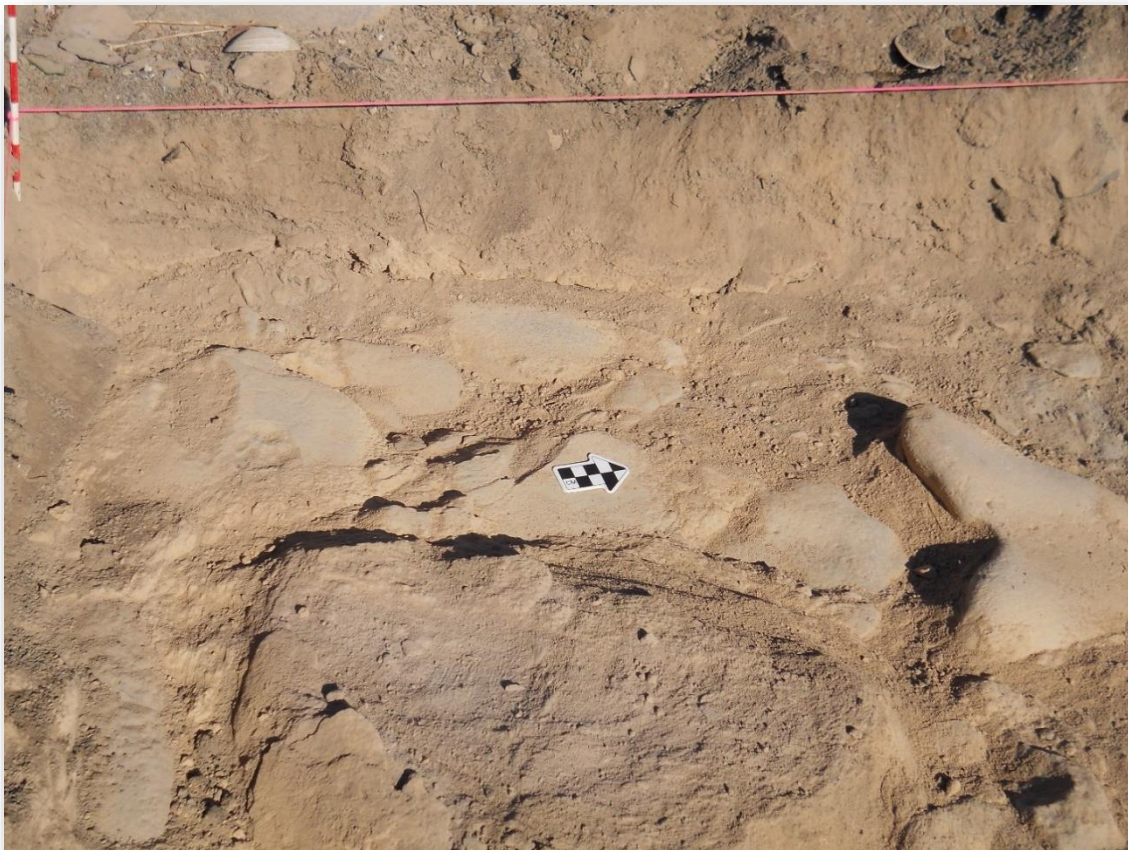
Figure 8. West wall profile of Unit 1

In the 10-20 cm level the soil/sediment changed in color to a pale yellow (Munsell 5Y 8/3), still sandy but finer in texture with a higher silt/clay content (Figure 8) The soil/sediments were slightly hard, somewhat compacted with large exfoliating and decomposing cobbles becoming exposed toward the bottom of the level. There were still a few modern artifacts present as well as local marine shell fragments and small pieces of charcoal. Pre-modern era artifact presence is discussed below.

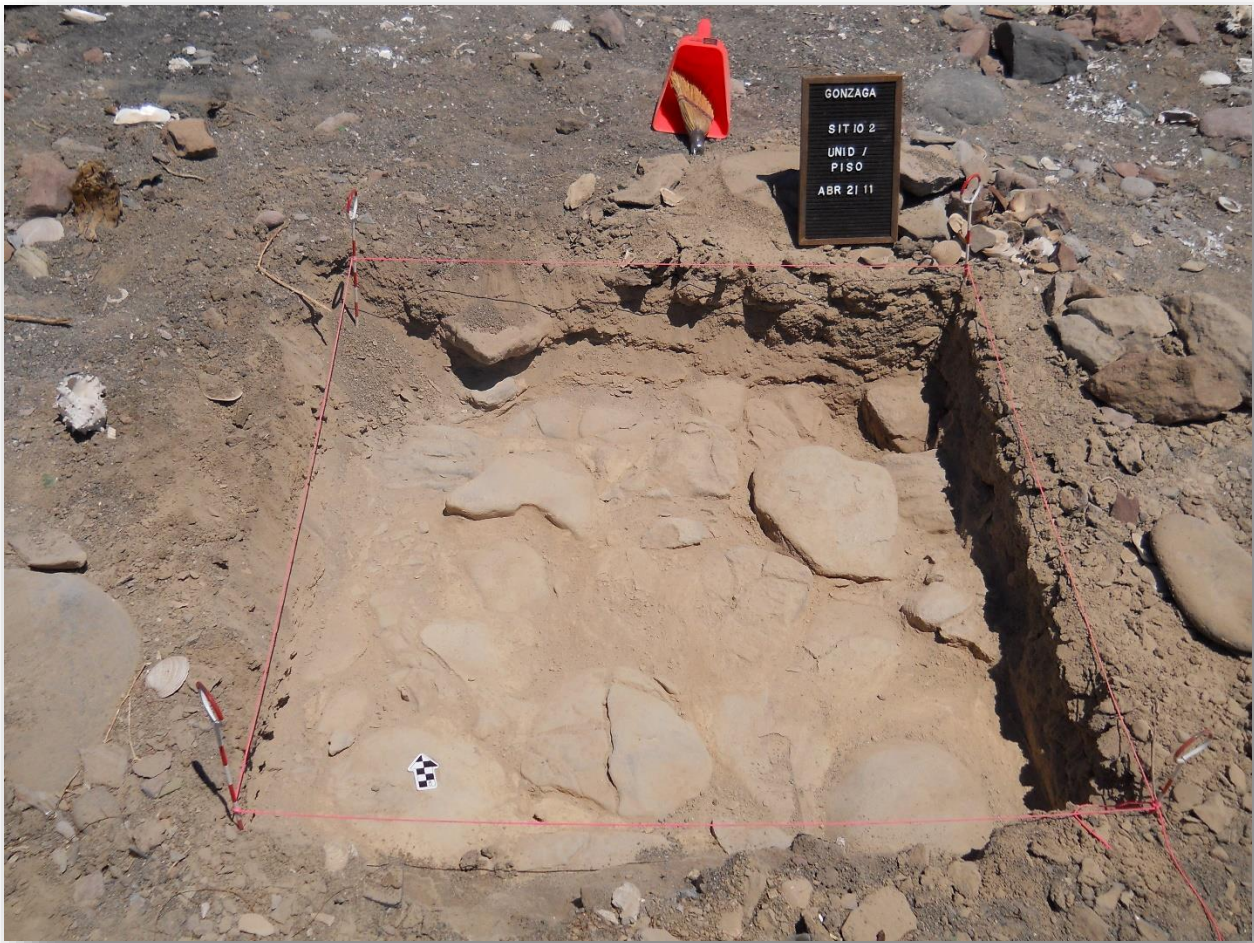
Figure 9. Stone pavement floor

While only a small portion of the interior of the structure foundation was excavated there is the appearance at about 20 cm in depth of the rounded, flattish cobblestones—likely from littoral wave-smoother rocks—that are rhyolitic and appear to represent a floor or pavement with the interstices filled with fine sediment and possibly even a thin layer of packed sediment placed over the cobbles as a compacted surface (Figure 9). However, it would seem that the stones were exposed during use to serve as a sturdy platform for storage and walking, but a compacted sediment placed over the stone platform cannot be dismissed. If the walls/foundations were originally cobbles/boulders consolidated with lime mortar as discussed below that has since leached out from exposure to the occasional rains onto the floor and/or there was an adobe upper wall “melted” away onto the floor and exterior, then perhaps this is one explanation for portions of the cobble covering.

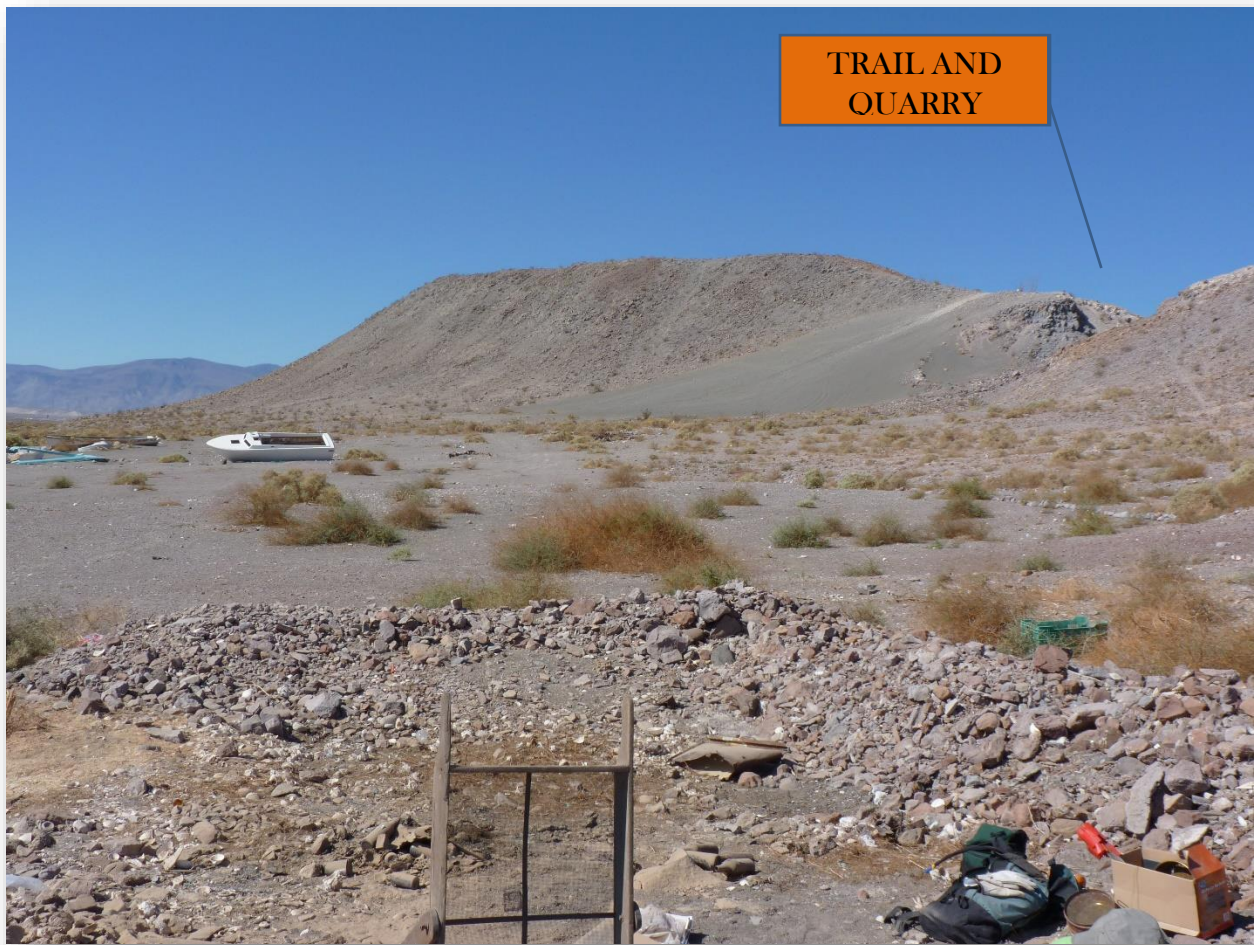
Figure 10. Trail and caliche quarry in upper right of photo

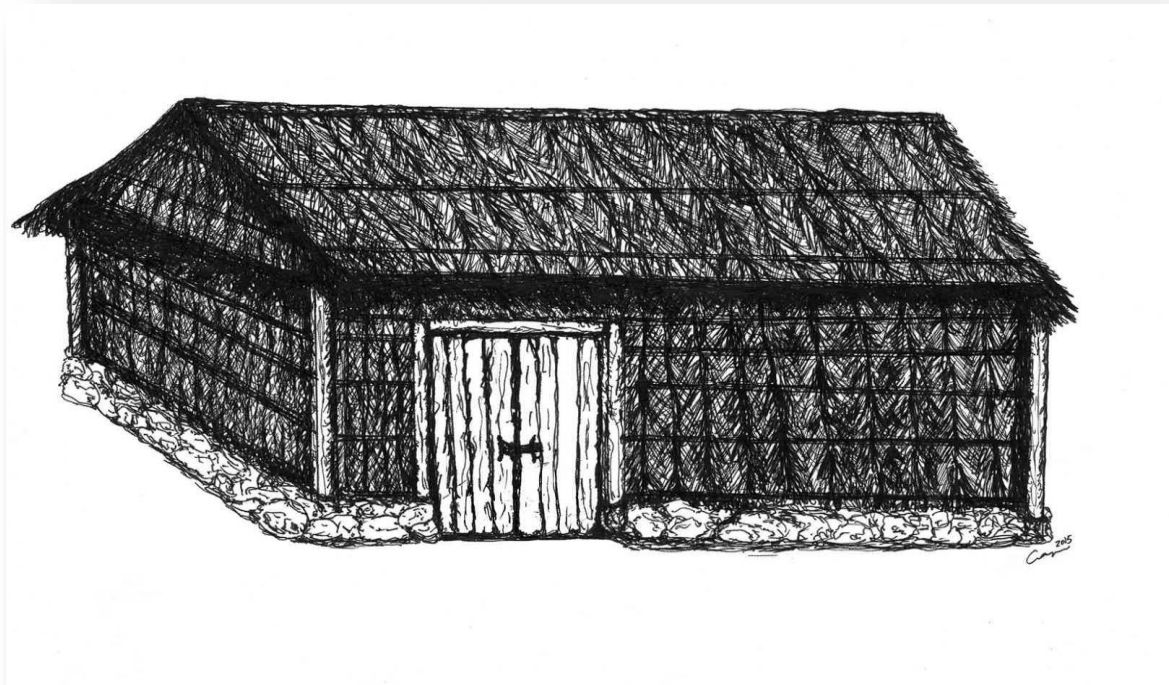
Figure 11. Reconstruction drawing of building

There is a clear entrance, perhaps one that was fitted with a thatch or wooden door. The superstructure is projected to have been palm logs and palm thatch roofing and sides, possibly even walls of petates or woven palm fronds or carrizo (*Arundo donax*) much like you see at modern or historic ranches in the central peninsula sierra (Crosby 1974: 63, 127; 1981: 5, 79, 93, 139, and 179). Split carrizo stems may have also been used in wall construction. Drawings by Jesuit priest Ignacio Tirsch in the 1760s of peninsula settlements offer at least possibilities of thatched open or boxed roof construction on more permanent dwellings (Nunis, Jr, 1972:41, 45, 47) as in the Crosby rancho photos. Another example of possible dwelling superstructure type is the conceptual reconstruction of a 1565 Spanish encampment of structures at Seloy in Florida (Enright 2013:15). Williams (1997: Figure 7) has offered a conjectural reconstruction of a substantial warehouse at the Presidio of San Diego that includes a stone foundation and boxed roof construction with tile shingles. Furthermore, Williams (1997:45) notes that a visitor in 1779 to the San Diego Presidio observed two warehouses measuring 14 and 22 varas long, the shorter

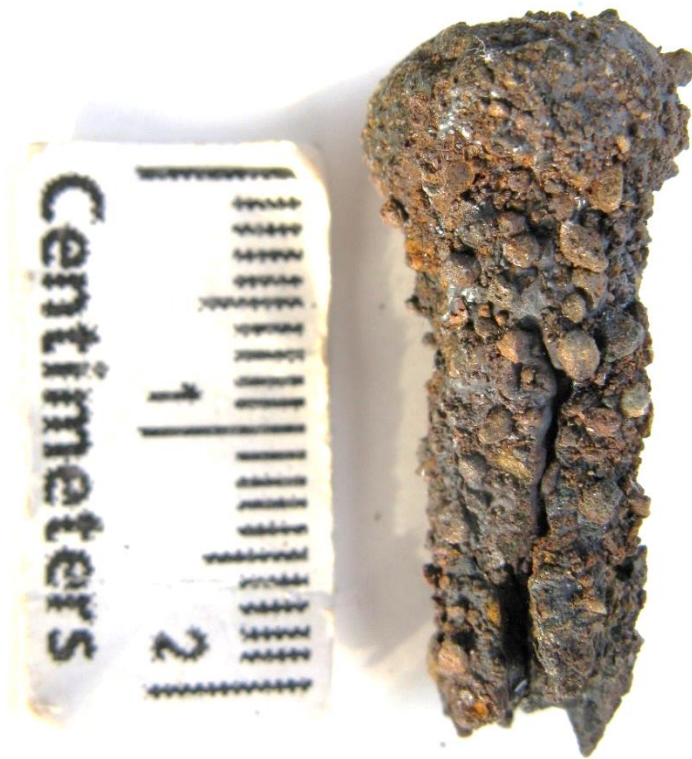
Figure 12. Rusted ferrous spike or nail head and shank portion

This artifact was found in the center of the structure ruins in the 0-10 cm level of Unit 1. It was likely about 4-6 cm long with a current corroded shank diameter of 8.29 mm and corroded head diameter of 11.8 mm. It was likely round in cross-section (Figure 12). The rapid deterioration of iron in this marine environment prevents a more accurate appraisal of the artifact in terms of hand-forged versus machine made. Whether this was related to a superstructure or not is uncertain.

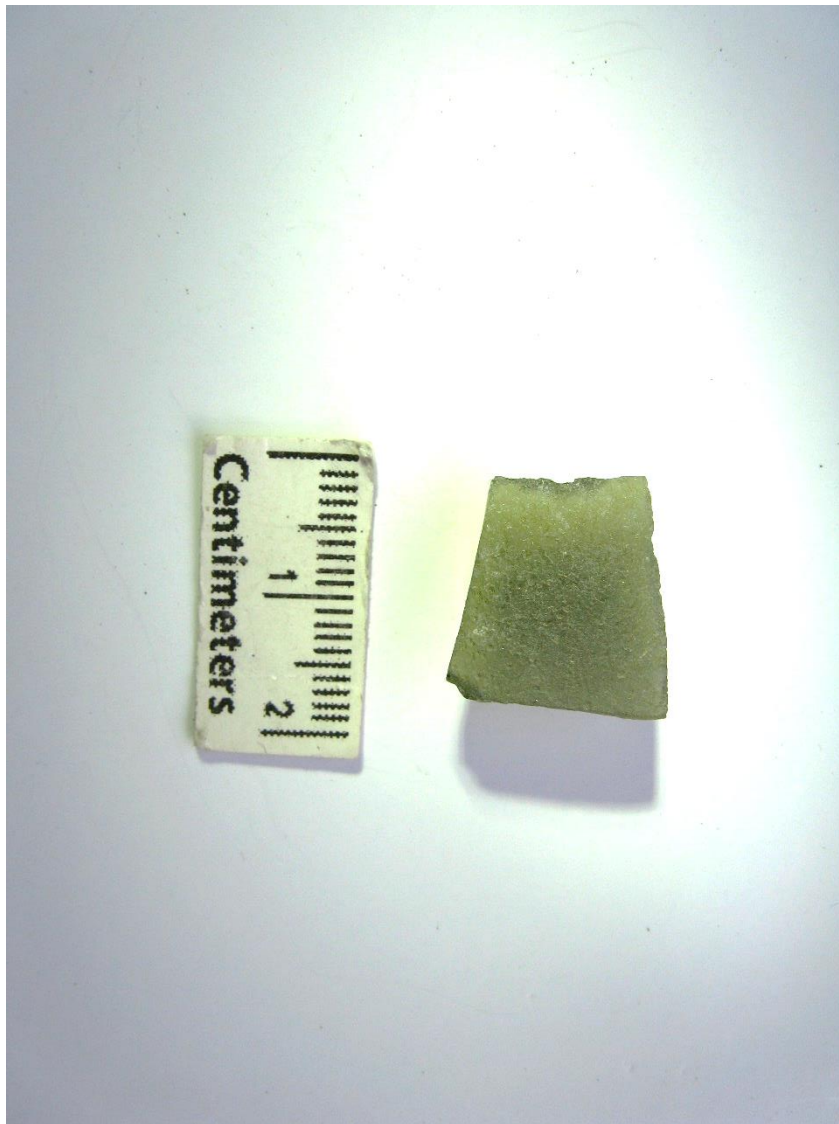
Figure 13. Green glass shard

A dark green glass sherd 16.74 mm x 15.42 mm x 1.96 mm thick was recovered from the surface of the structure remnants. The curvature of the sherd suggests a vessel of 75.12 mm in diameter or possibly 3" as occurs among some modern wine bottles. The shard is pitted and weathered on all but one edge that has been recently broken (Figure 13). Without further analysis this shard's connection to the ruins must remain uncertain.

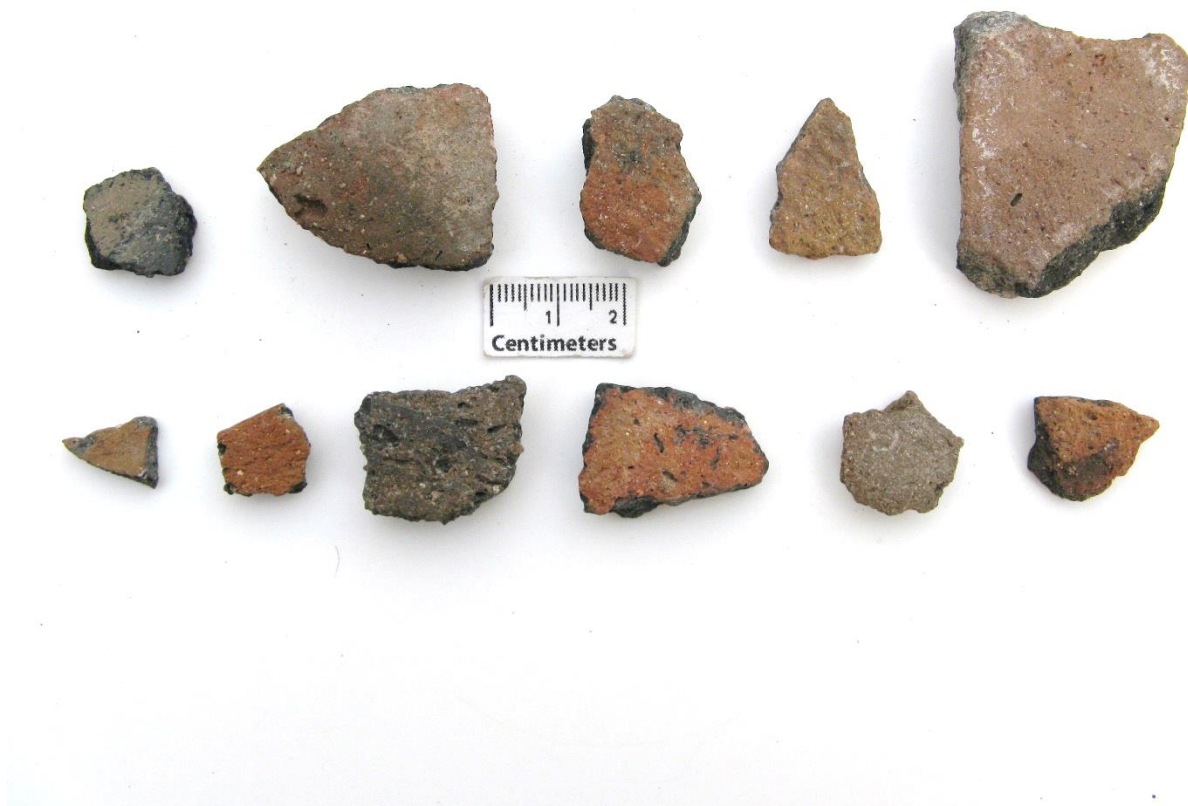
Figure 14. Plainware pottery sherds

There are two principal groupings of sherds: glazed and non-glazed. Within these two groupings there are likely types in the cultural and temporal sense discussed briefly below. None of the sherds exhibit signs of cooking/smudging, keeping in mind the caveats listed above. Eleven of the sherds fall into the non-glazed category (Figure 14) with characteristics listed on Tables 1 and 2. The exterior colors are quite variable including light brown, brown, reddish brown, light brownish gray to reddish orange, and red as defined by Munsell soil color charts. Interior colors most often do not match the exterior colors at least partially due to probable firing oxidation variations. These colors include light reddish brown and reddish brown, dark reddish gray and reddish gray, dark gray and pinkish gray, and red. The cores are gray to black likely indicating open, low temperature firing in an oxidation environment (but see de Barros 2013:16).

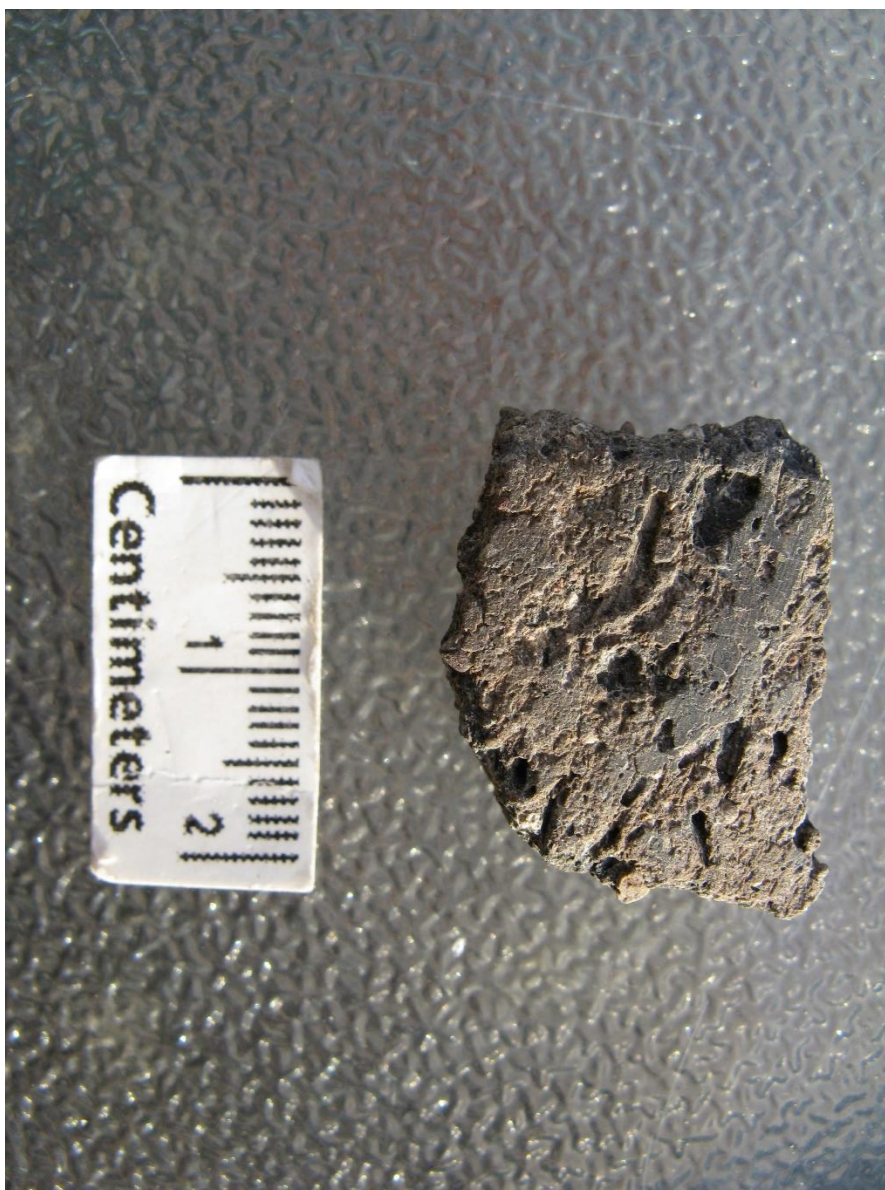
Figure 15. Example of indications of fiber temper use as seen in surface voids

The thicknesses of these 11 sherds averages just under 7mm with a range between 4.3 and 10.6 mm. Five exhibit burnishing, although weathered surfaces were present on some sherds. A few exhibit scraping and wiping marks. The paste appears to be fine to medium with either sand included naturally in the clay or added for tempering. Visible inclusions include angular to sub-angular quartz and other minerals not identified (no mica is readily apparent) with about 5-30% of the core matrix including these visible grains. Most significant is the evidence of fiber tempering in 10 of the 11 sherds due to voids in the surfaces and paste that appear to be plant remnant molds (see Figure 15). It is probable that utilitarian-directed bowls, jars and ollas are represented by these sherds.

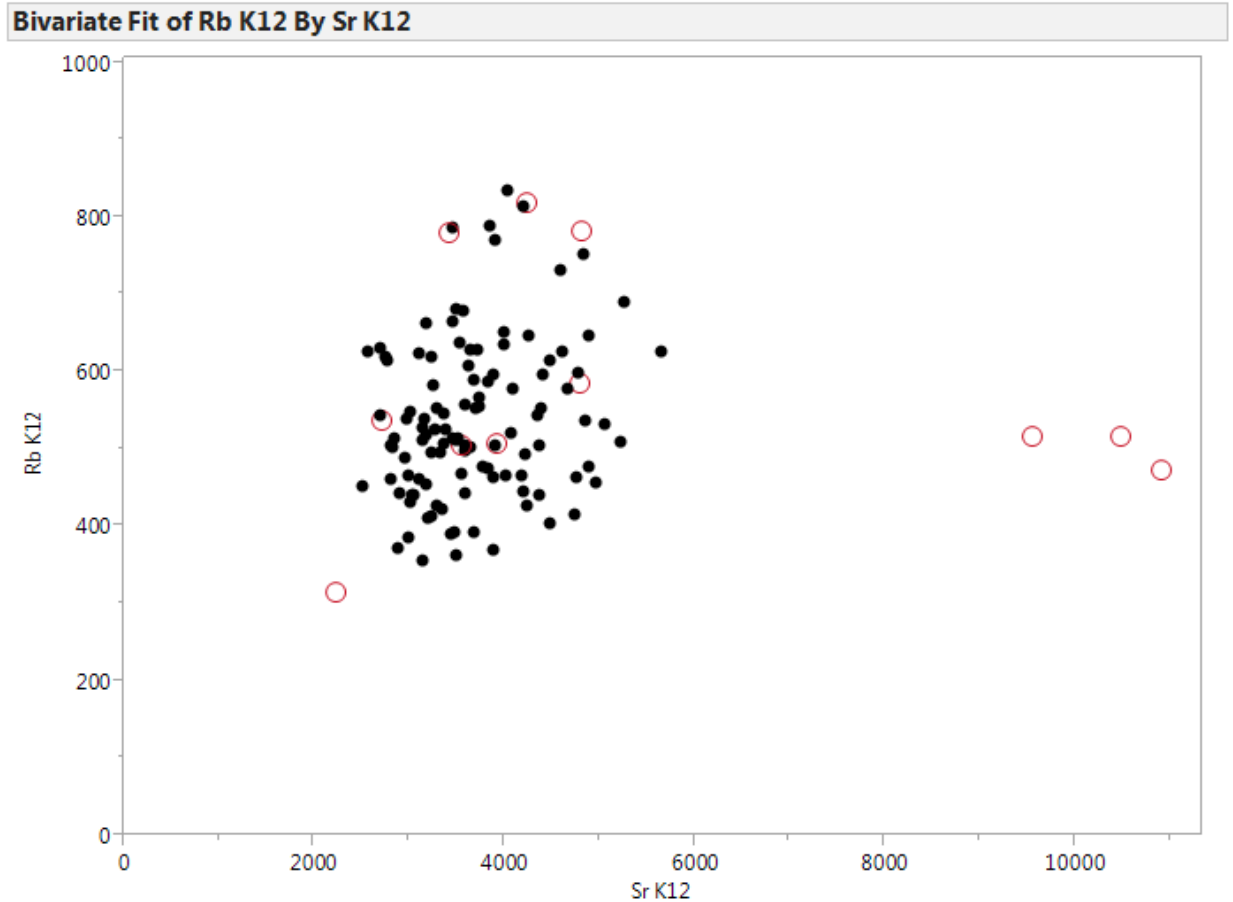
Figure 16. Comparison of Gonzaga (red circles) and Velicatá (solid dots)
select element concentrations

Previous studies by the author (1994, 1995, 1997) and Williams (1995, 1997) to the south down the peninsula Gulf coast at Bahía de los Ángeles, Bahía las Ánimas and from missions San Borja and San Fernando Velicatá (to the west) resulted in the discovery of similar pottery sherds from mission and Native American Indian sites (also see Tuohy and Strawn 1986, 1989). Many of these sherds appear to match those from the Bahía de los Ángeles locality discussed by Massey and Osborne (1961:343) and Davis (1968:184). Preliminary XRF studies by Dr. Lee Panich indicates that some of the Gonzaga sherds utilized the same clay as found evident in pottery sherds from Mission San Fernando de Velicatá. Others from Gonzaga are not a match to Velicatá specimens (Figure 16).

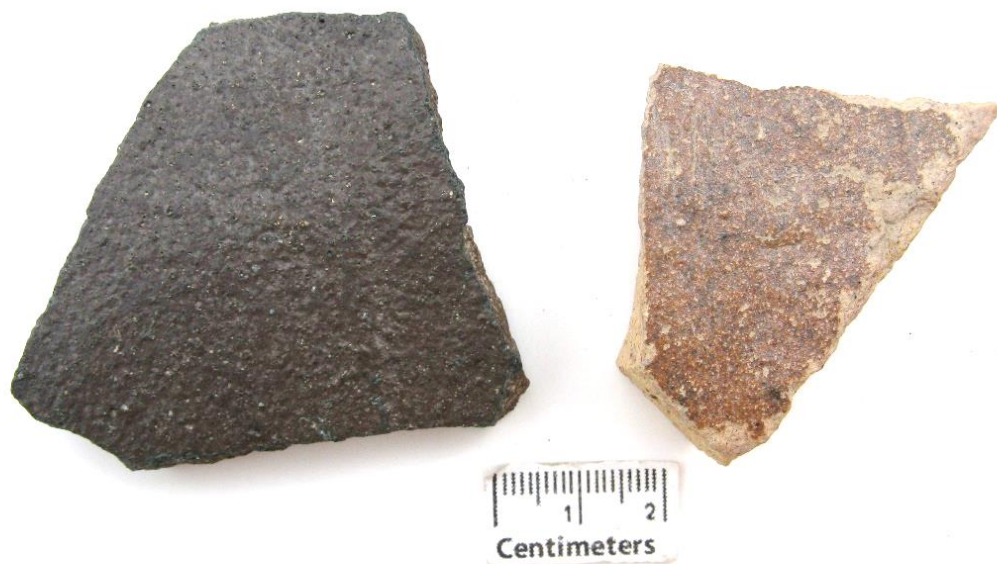
Figure 17. Glazed pottery sherds exterior view

The two glazed wall sherds are quite dissimilar in many characteristics (Tables 1 and 2) (Figures 17 and 18), although both represent rather large vessels, perhaps for storage. One sherd is glazed on both interior and exterior surfaces, while the second sherd is only glazed on the exterior. The outer color, dark reddish brown and reddish brown, respectively, is similar on both sherds, while the one sherd has a pink to pinkish white interior with a rather sloppy applied slip. It is suspected that these are thrown vessels as opposed to the hand-modeled pottery previously discussed. The first of these two sherds has an apparent fine sandy temper while the second sherd has a silty paste with occasional visible sand grains of variable minerals. The core colors suggest they were fired at high temperatures, likely in a kiln due to their level of vitrification and absence of pores. Other characteristics are noted in Tables 1 and 2.

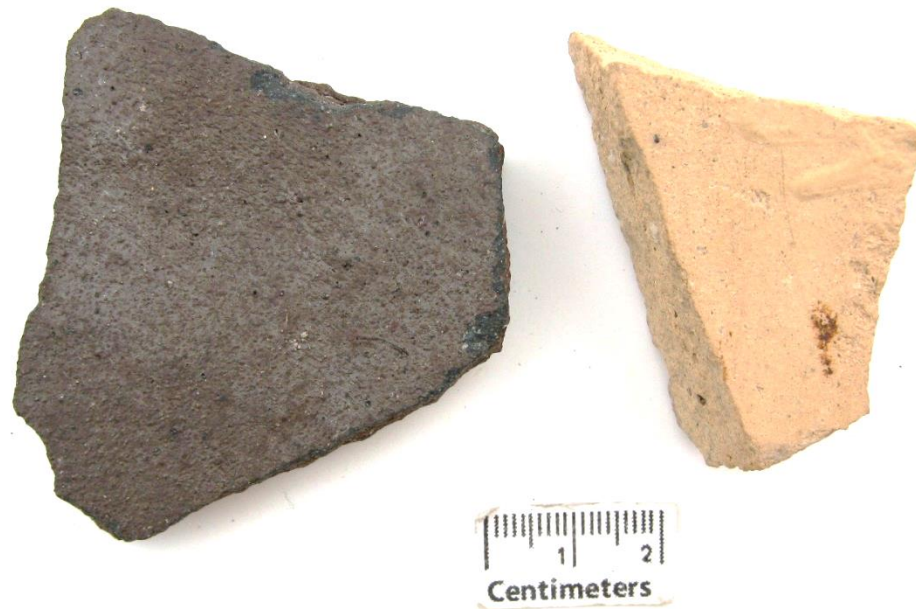
Figure 18. Glazed pottery sherds interior view

were definitely from the colonial period, possibly Galera Ware. This may be conceivable when considering the descriptions and illustrations of Fox and Ulrich (2008:50-56) for Galera, but these sherds also resemble their Red Brown and Dark Brown wares all dating to the time of missionization in Texas (Fox and Ulrich (2008:39). As indicated by Fox and Ulrich (2008: 50), Galera wares at Texas missions are thin, averaging 3 to 4 mm in thickness with an orange paste, not like the sherds from around the ruins. It is also possible that the fine-textured paste example (No. 13) could be a Rey Ware as discussed by Deagan (1987:51-52) for Spanish colonial sites in the Caribbean-Florida area. In any case, these two sherds strongly suggest a Spanish colonial association with the structure remnants, pottery most likely brought to the area originally from non-peninsular sources (also see Voss 2012:44-45).
